Breakage Analysis for CERAN®- Cooking Surfaces

Presentation of typical breakage structures

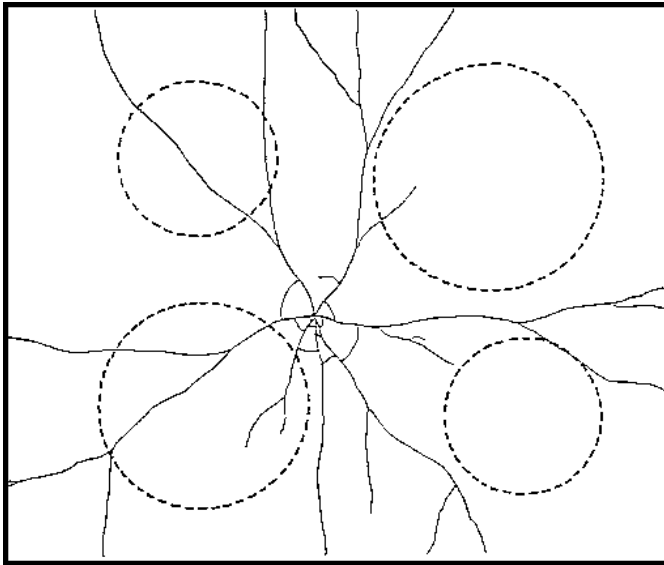
Type 1: Impact/collision pressure

A heavy and sharp edged tool or kitchen utensil has been dropped from considerable height onto the CERAN panel.

Breakage pattern:

Breakage starting at point of impact; in this case in the centre of the panel; several primary breakage lines extending towards the panel edges; the number of breakage lines depends greatly on the impact energy (i.e. intensity of impact). The long primary breakage lines may be linked by secondary short crossing breakage lines (like a spider's web).

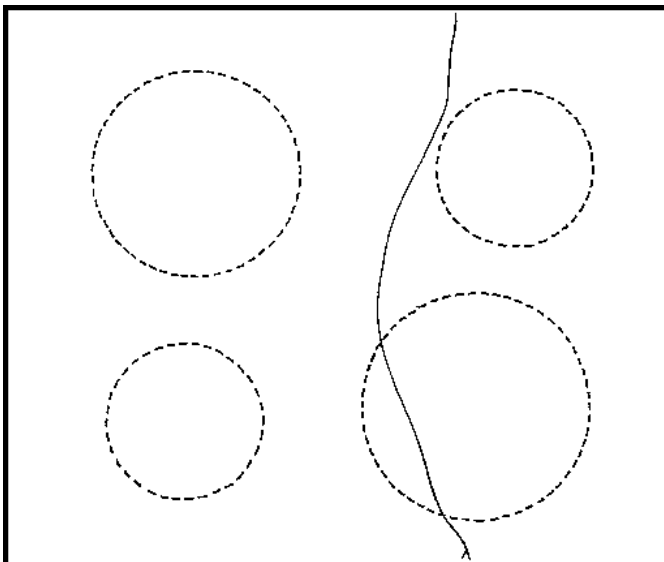
Type 2: Bending

The cooking panel was permanently bent. Possible causes for bending:

- twisted frames
- heating elements pressing against the bottom side of the panel with too high forces

Breakage pattern:

A single fracture usually flows across the surface. Acute triangles are possible.

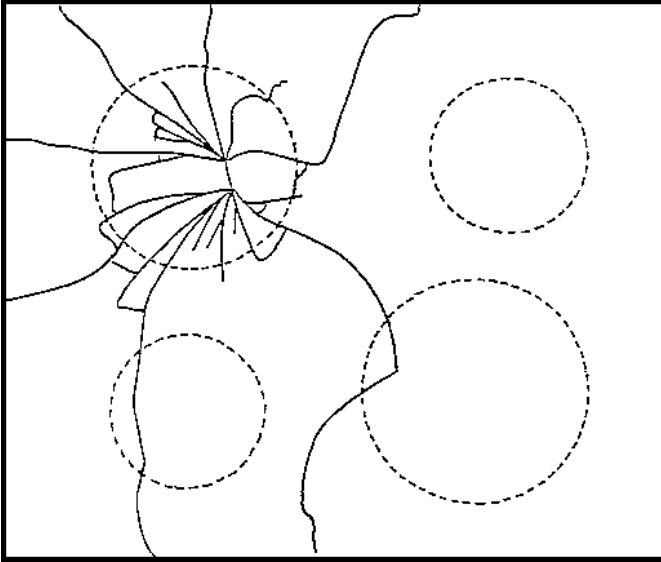
Type 3a: Fracture by overheating

In the case below the surface was overheated due to a heating system that caused an excessive time / temperature stress. In the case of strong overheating, the surface shows within square centimeters cloudy or blue coloured signs. This is conspicuous especially by holding the surface in front of a light source.

Breakage pattern:

Breakage initiation within the cooking zone. The primary breakage line is normally 0.5 to 2 cm long, at both its ends usually dividing into several breakage lines. Usually a change of direction for the propagation of the breakage lines will be observed near the cooking zone edge.

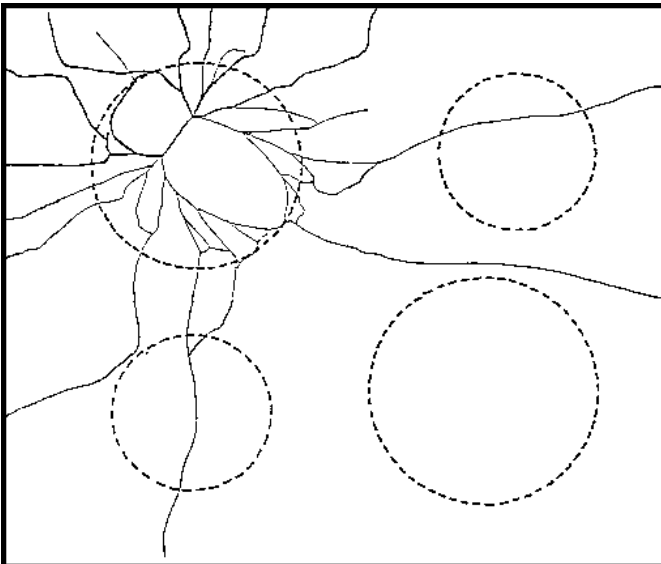
Type 3b: Fracture by overheating

Breakage pattern:

Breakage initiation within the cooking zone. The primary breakage line is normally 0.5 to 2 cm long, at both its ends usually dividing into several breakage lines. Usually a change of direction for the propagation of the breakage lines will be observed near the cooking zone edge.
