EEH/EEB 6100.5 and EEH/EEB 6150.5

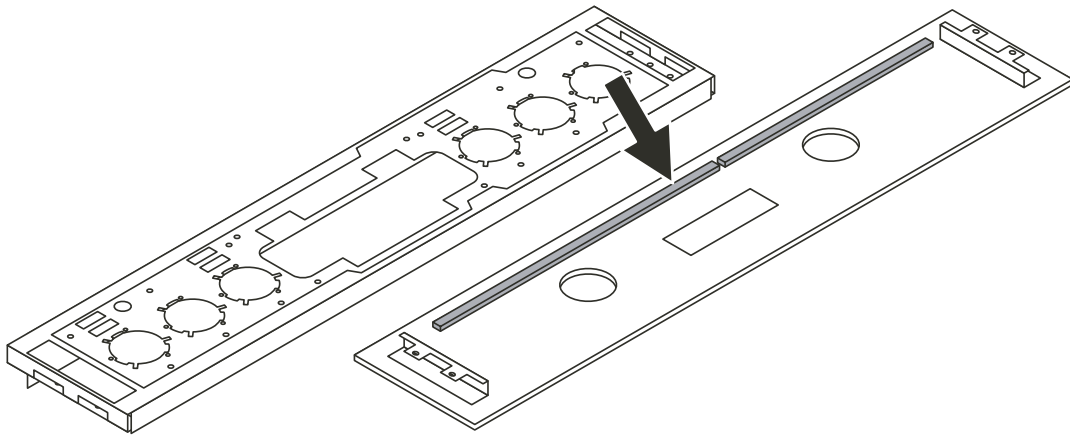
It is possible that the sealing (spare-part no. 535 995) may have been incorrectly glued in if it is no longer possible to adjust the clock (spare-part no. 528 383) with three buttons and the clock (spare-part no. 528 385) with five buttons.

1. Completely remove the foam sealing material on the back of the front pane of glass.
