Rectifying automatic switch-on with the EEB 6550.8

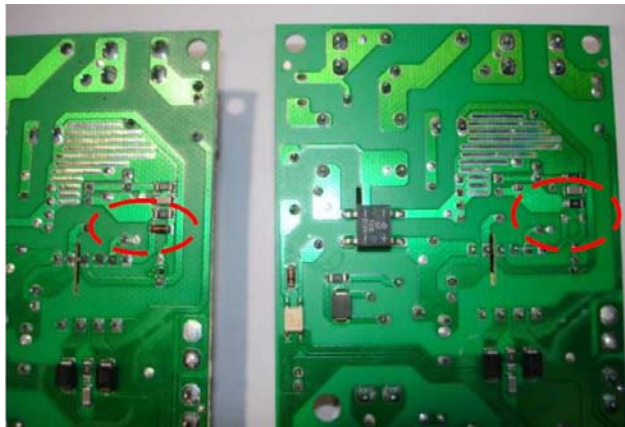
The cause is the failure or the loss of a diode. This fault only occurs with the following models when a special plastic holder is mounted.

The defect becomes apparent at the back of the power supply unit with the spare-part no. 543355.

Power supply unit with a
welded on diode

Defect power supply unit
with no diode

Proceed as follows to repair the fault:

1. Check the model designation and the variant number.
2. Remove the cover of the switch panel and the screws on the power supply unit.

3. Use a standard tool to turn the support out of the plastic holder, as shown on the photo.

4. Install a new power supply unit (spare-part no. 543355).
5. Check the connections on the electronic unit and carry out a functional test.
