Unreliable touch control operation KD9570.0 J KD9570.0BC

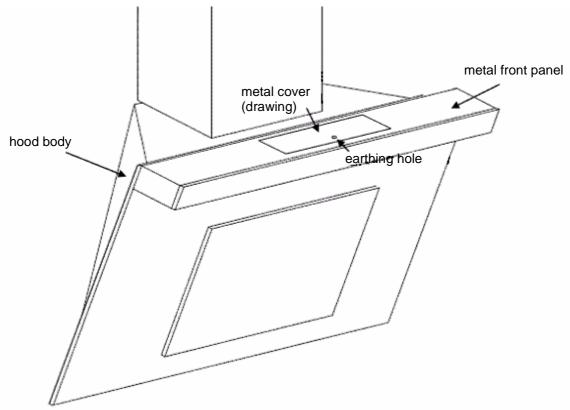
In the event of control problems with touch control **spare-part no. 543624** (code number C21213502) a check will need to be carried out to determine whether there is an electrical connection between the metal front panel and the body of the hood (check for transmission with an ohmmeter).

Models produced approximately as of autumn 2010 use a metal cover with an earthing hole (see the drawing), so that this error has been rectified for appliances as of autumn 2010.

It is not necessary to earth the touch control; only a connection between the body of the hood and the metal front panel needs to be made if problems with the touch control occur. This relates to the potential equalisation of the touch control "metal surrounding". See illustration:
