Responsible: D. Rutz
Date: 3.07.2006

Snorkel noise or high rumbling sound during operation IGV 645...

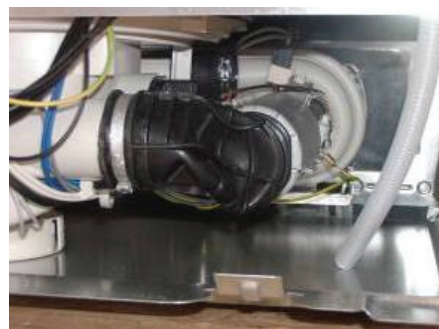
After a short time the spray pump will seemingly drive slower and the sound goes down. After the warming up of the water the bend slip in and close the flow rate. Strange snorkel noise is to hear.

The bend hose is mounted wrong.
To high tension at the bend through misaligned assembling.
