Date: 25.03.2013

Less tension in the door

Appliances

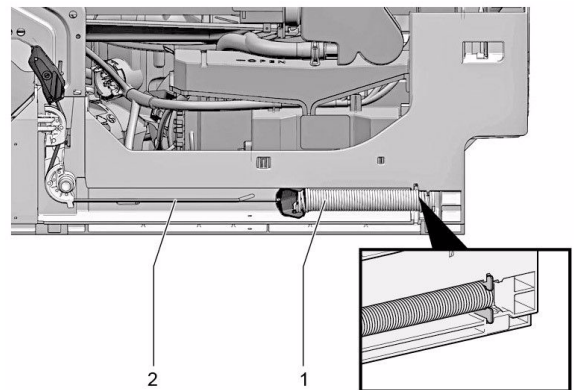
The door has less resistance when opening. The door **will not remain** in a mid-opened position and will drop to fully open.

The rope can become loose from the spring connection or connection can break on the left or right side of the dishwasher.

If this failure occurs, the spring system must always be changed together in pairs:

- 2 springs (position 1)
- 2 ropes (position 2)

The spring repair kit consists of two springs, two ropes and a sticker to indicate the unit has been repaired.
