Support

Drain pump blockages

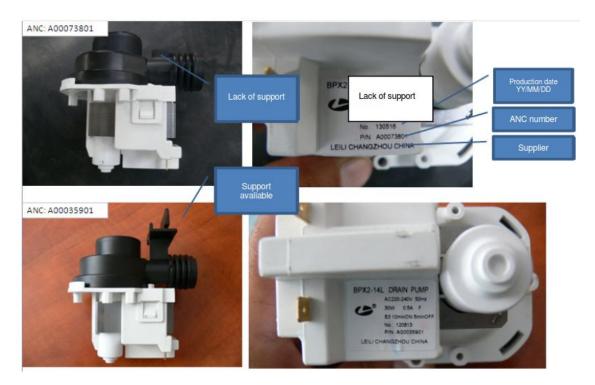
It is possible for drain pumps from manufacturer Leili produced before 24.05.2013 to become jammed.

1. Identify the drain pump you have by comparing the data label with those below. The later pumps also have a support bracket.

2. Replace with a new one produced after 24.05.2013. Do not unblock the pump, replace with a new one! Specific part numbers can be located on TDS for the model you have.
