**IKEF 308-5 Z 3 - PNC: 925 703 659****EMZ 26 CLC COMPRESSOR DOES NOT FUNCTION
(PROTECTIVE MOTOR SWITCH DEFECT)**

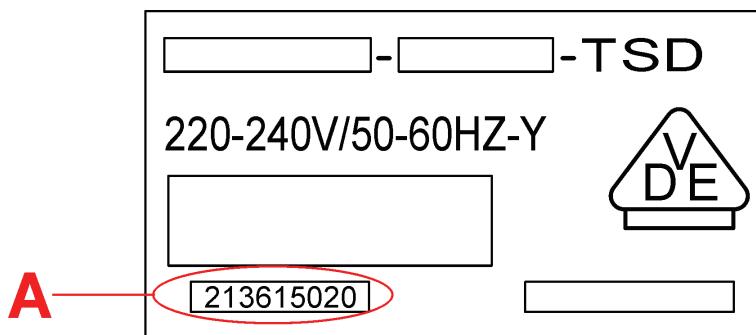
You can use this number on the nameplate to see whether a new protective motor switch needs to be installed.

The protective motor switch must definitely be replaced. It can be ordered under spare-part no. 43 27 71.
