Responsible: U. Laarmann  
Date: 19.01.2007

### Noises caused by the flow of the IKEF308-5Z3 refrigerant

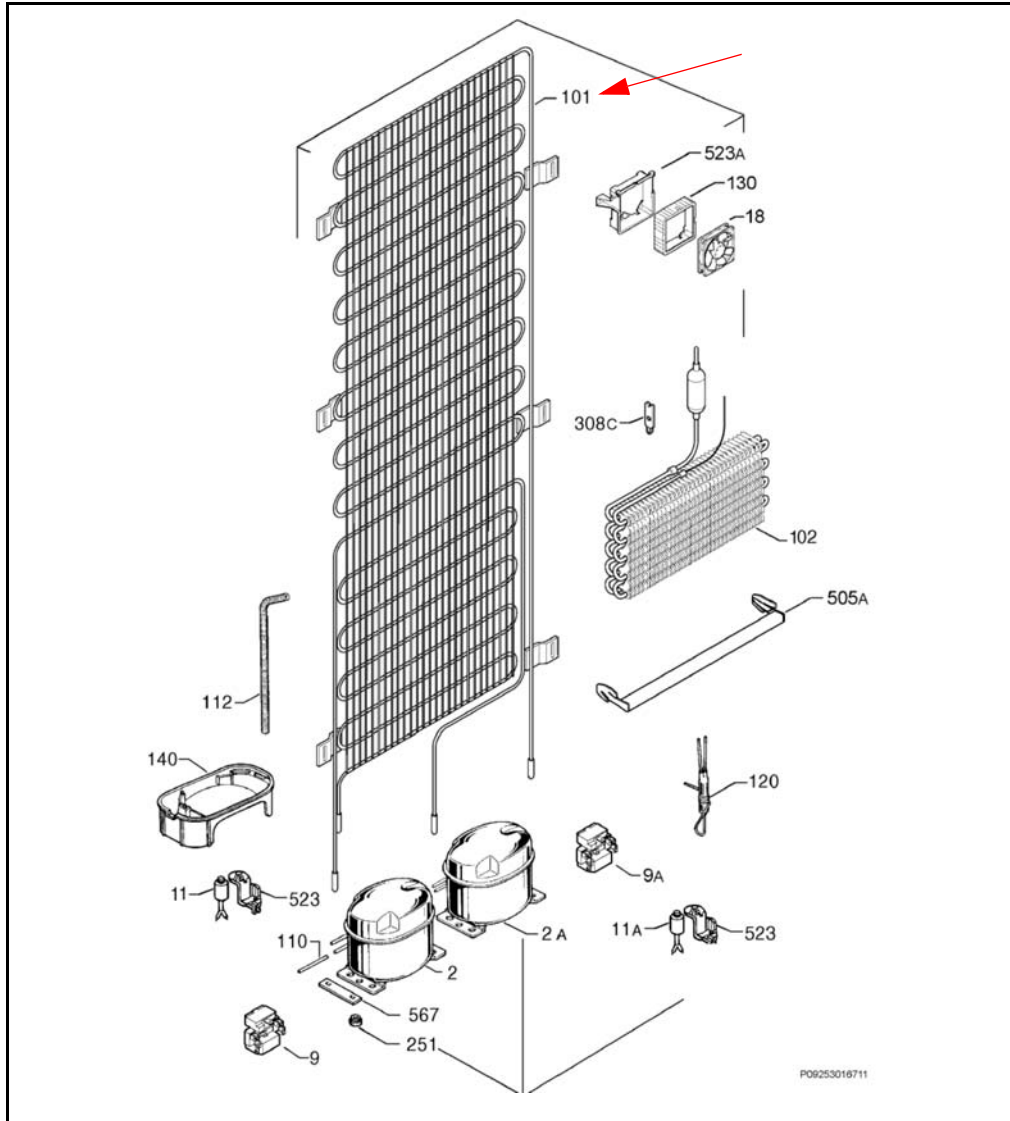
The flow of cooling gas for the IKEF3085Z3 PNC 925703xxx (see chart A) for appliances up to serial number 626xxxxxx caused loud noises in the refrigerator/0° section.

If customers complain about excessively loud noises in the appliances shown on chart A with the previous condenser, the following component must be used for the modification indicated above:

In order to rectify the problem it was necessary, as of serial number 627xxxxxx, to replace the condenser and to adjust the refrigerant volume.

Spare part. nr.	Description	Illustration position
433726	Condenser	101 (see page 2)

1. Make sure that the PNC of the loud appliance has been included on chart A and check to see whether the old condenser has been fitted (filling quantity on the nameplate).
2. Remove the appliance from the installation niche.
3. Disconnect the appliance from the mains supply.
4. Disconnect the condenser connection.
5. Remove the old condenser.
6. Cut the pipes of the two drying cartridges and replace them with the two new pipes.
7. Install the new condenser.
8. Re-connect the pipes to the new condenser.
9. Refill the cooling circuit, observing the new volume of gas (38 g. for the two sections).
10. Re-connect the appliance and push it into the installation niche.
11. Once this has been completed adjust the volume of gas indicated on the nameplate, indicating the new quantity (38 g. for both sections).
