IKE 339 / KE 680-1-2T

Problems with draining off water from defrosting

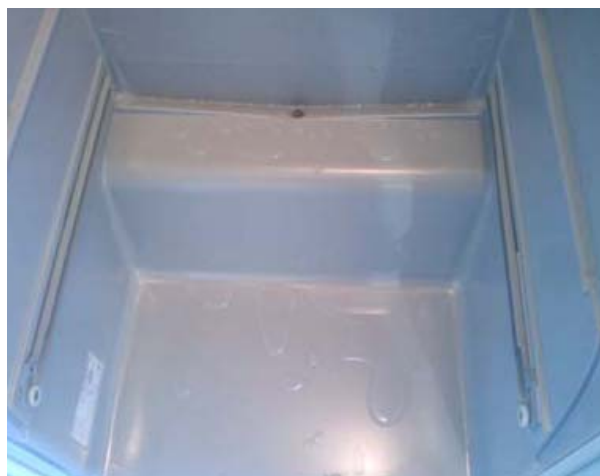
This error may occur when the guides of the refrigerator drawer have been mounted too far to the back. The drawer will then touch the bottom of the refrigerator section and prevent the condensation water from flowing into the discharge hole during the defrosting procedure in the refrigerator.

The guide rails only need to be fastened in a different position to solve this problem.

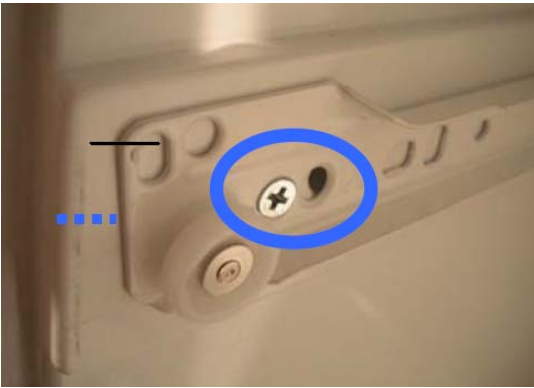
WRONG - guide rail in the first hole

1. Check whether the guide rails are fastened in the first hole.
2. Remove the screws and fasten the guide rails again in the second hole (further to the outside in relation to the refrigerator section).

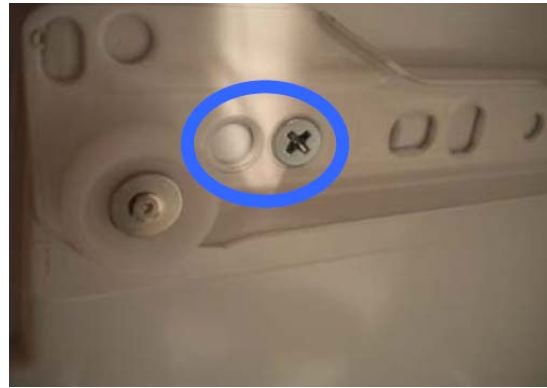
RIGHT - guide rail in the second hole
