Problem with door seals in built-in appliances

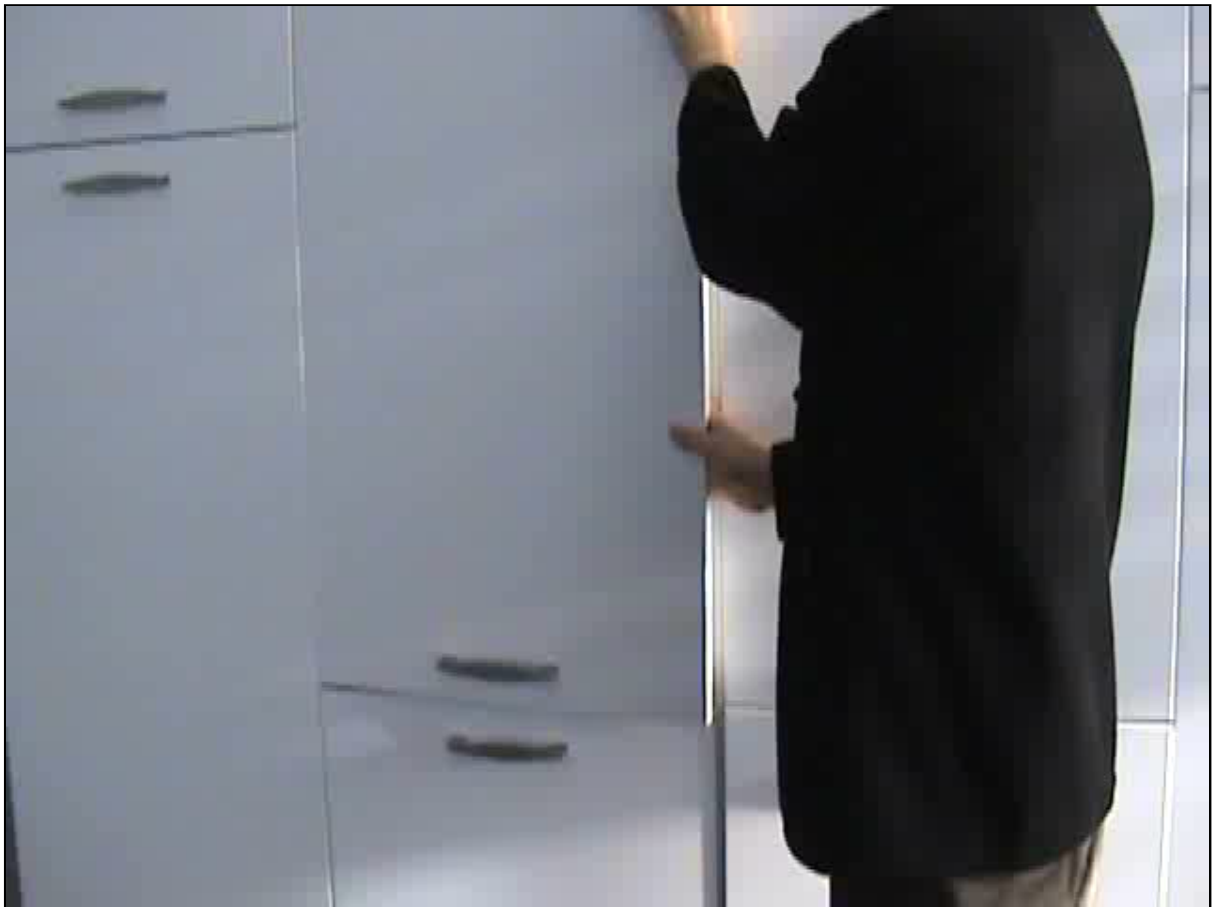
Door seals may remain compressed, especially on the side opposite the hinge, when the door stop is changed.

A loss of elasticity means that the seal no longer has the maximum holding force it needs to close the door.

In this case condensation inside the refrigerator becomes excessive as air gets in.

To make the seal elastic again, simply pull on it as shown in the video on the next page. If the elasticity of the seal is not restored, the procedure can be repeated by warming up the seal with a hair dryer.
