Replacement of the cooking zone temperature sensor (spare-parts no. 538 216) on the EKI

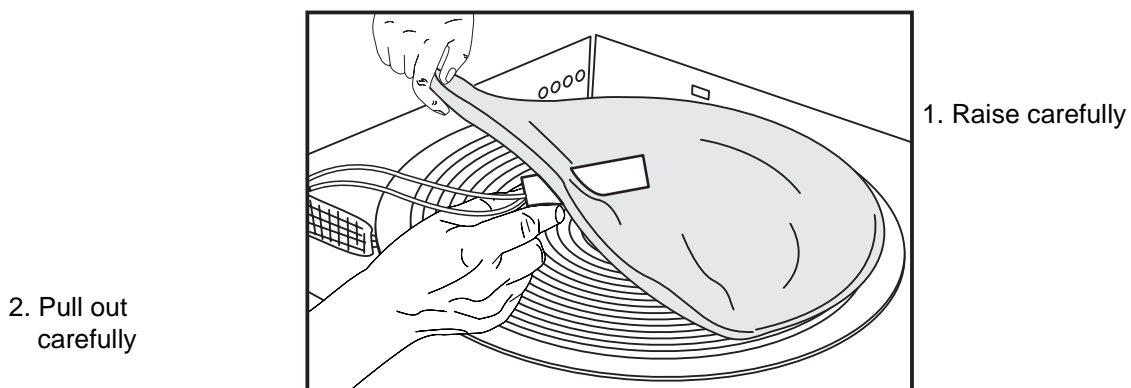
As shown in the following picture, carefully raise the insulation of the cooking zones where the sensor is defective and pull the sensor out through the opening in the centre of the insulation.
