Assessment of enamel damage to built-in electric cookers/ovens

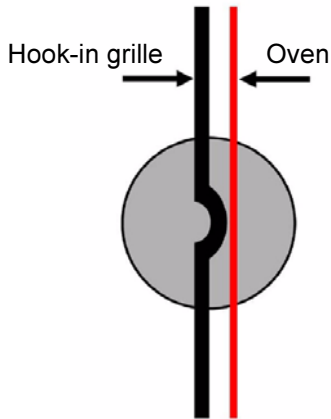
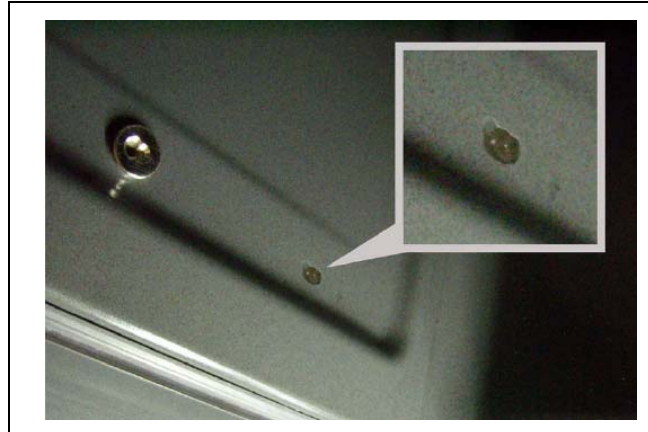
Flaking in the oven with hook-in grille

Flaking enamel on side wall (on right or left) on the contact surface of the hook-in grille.
Cause of damage not clearly identifiable. Any damage in transit caused by unsecured accessories in the oven.

Warranty claim!

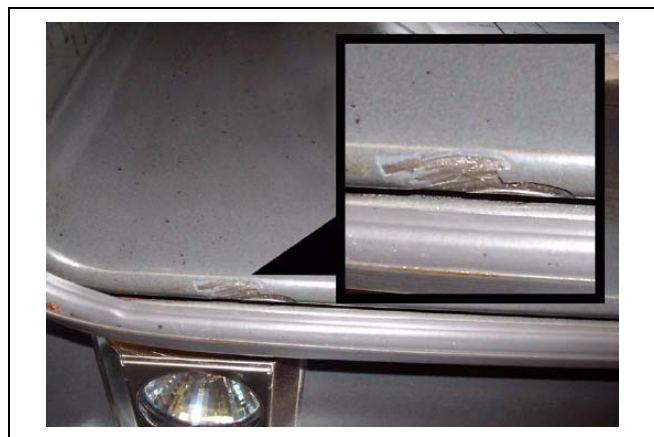
Flaking at the front of the oven (1)

Extensive flaking enamel with continuous longitudinal cracks along the lower curve.

Cause of damage: enamel layer too thick.

Warranty claim!

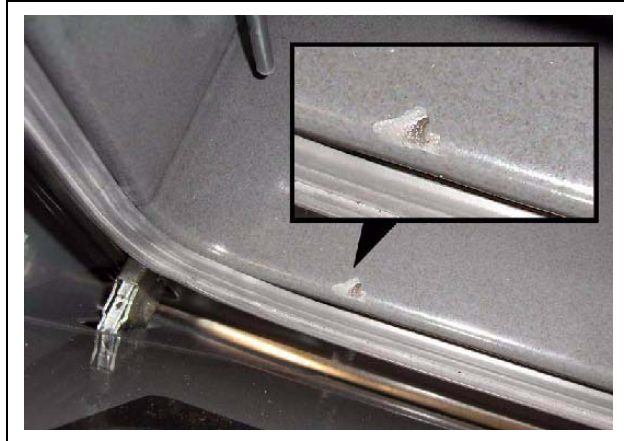
Flaking at the front of the oven (2)

Flaking enamel along the upperside of the curve.

Cause of damage: Baking/roasting accessories striking/banging against the oven.

**No warranty claim!**

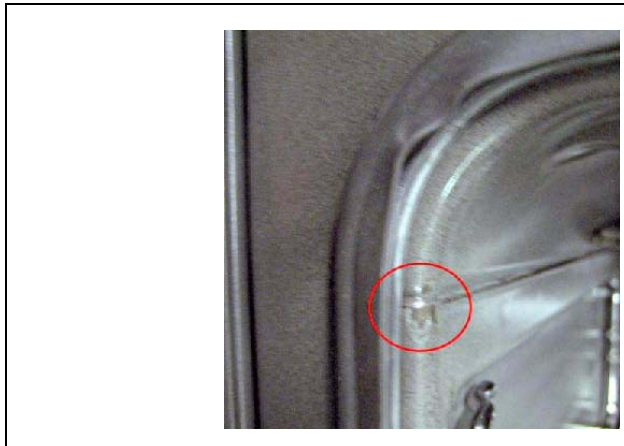
Flaking in the oven corner

Flaking enamel along the upperside of the curve.

Cause of damage:
Baking/roasting accessories striking/banging against the oven.

**No warranty claim!**

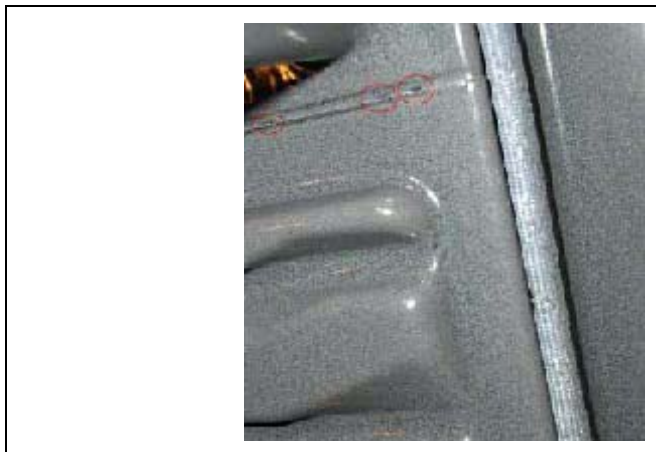
Transition side wall/ceiling

Depressions, ridges, gap, thin layer - uneven edge in the seam.

Cause: "normal" production status due to production.

Function not impaired.

**No warranty claim!**

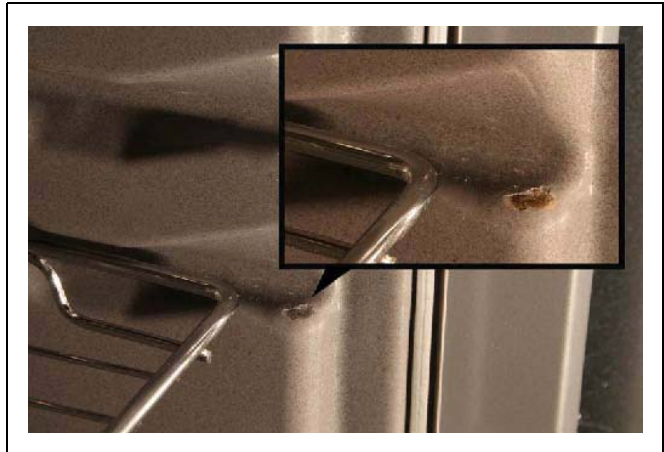
Flaking on the oven ribs

Flaking enamel along the front shelf edge of the cooking compartment rib.

Cause of damage: Due to improper handling of the accessories!

Utilised accessory pulled out too far without load removed. As a result, too much pressure on the cooking compartment ribs damages the enamel.

**No warranty claim!**

Information in the instructions for use!

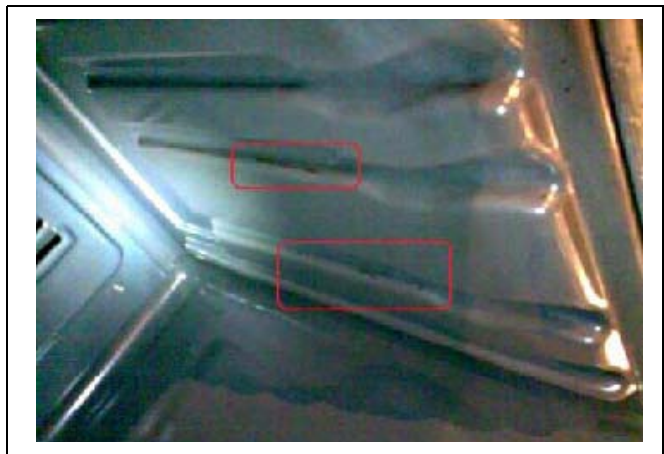
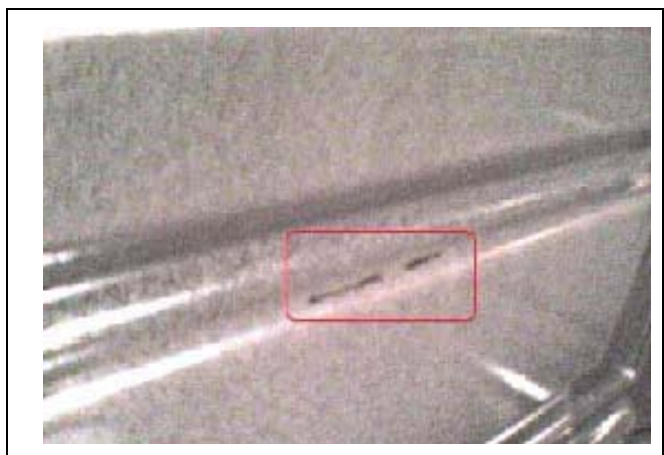
Stress marks on the oven ribs

Black stress marks on the edges of the ribs.

Cause of damage: the ribs are dry and the baking sheet therefore rubs against the ribs (enamel on enamel).

After several baking processes a "lubricating film" forms again!

Function not impaired.

**No warranty claim!**

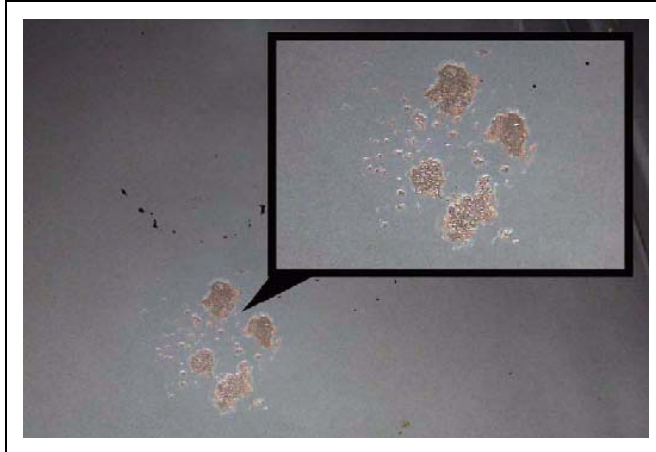
Flaking on the oven floor (1)

Flaking enamel on the oven floor without ridges or depressions.

Cause of damage: Overheating of the enamel due to heat accumulation.

Cold shock caused by cold water. Floor is partly corrugated.

**No warranty claim!**

Follow information in the instructions for use, see "General instructions".

- Do not place bread baking stone, baking/roasting accessories or cooking utensil directly on the floor.
- Do not pour cold water into the hot oven.
- Do not line with aluminium foil.

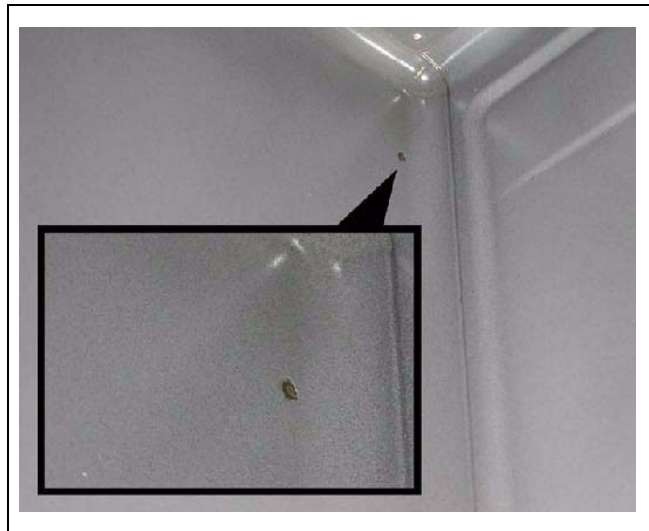
Flaking on the oven floor (2)

Ridge (mound) tangible?

Yes: External impact effect!

Depression (dent) tangible?

YES: Internal impact effect!

Cause of damage:

Improper handling of hook-in grille/bars, telescopic runners, baking/roasting accessories.

**Warranty claim if ridge inwards!**

**No warranty claim if depression outwards!**

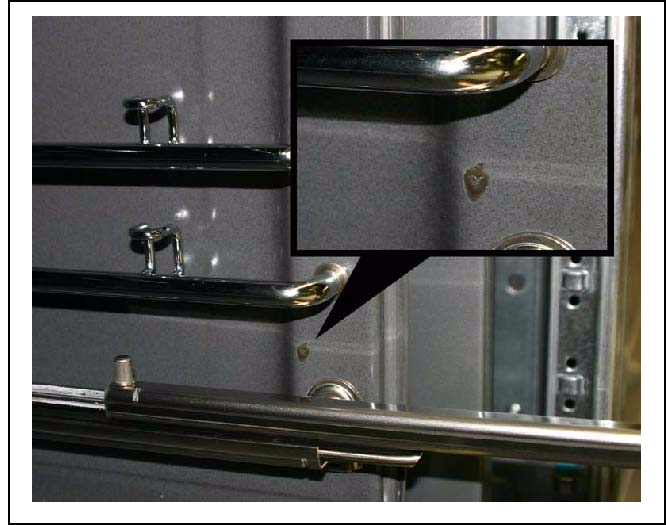
Flaking in the oven with telescopic runners

Flaking enamel at the front between the holders of the telescopic runners.

Cause of damage:

- Baking/roasting accessories were not inserted correctly and strike the edge when pulled out.

**No warranty claim!**

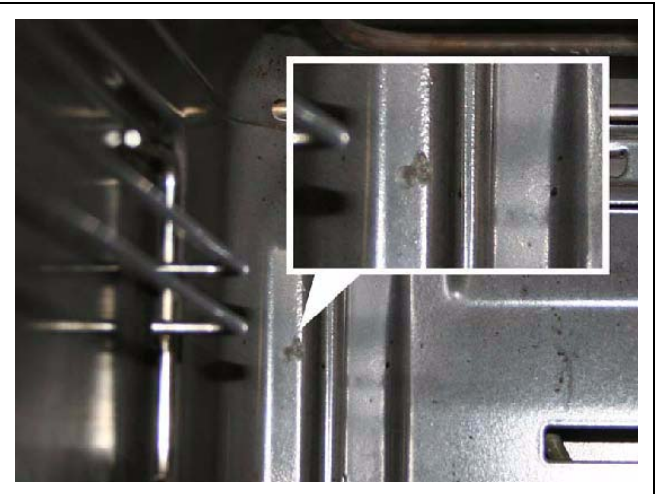
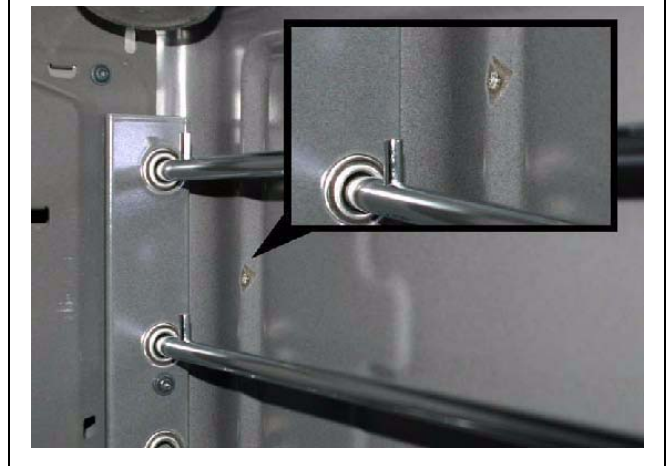
Flaking in the back of the oven

Flaking enamel at the back side, on both left and right

Cause of damage:

- Flaking in the extension of the shelf rail!
- Baking/roasting accessories were struck at the back due to too forceful insertion.

**No warranty claim!**

Follow information in the instructions for use, see cause of damage!

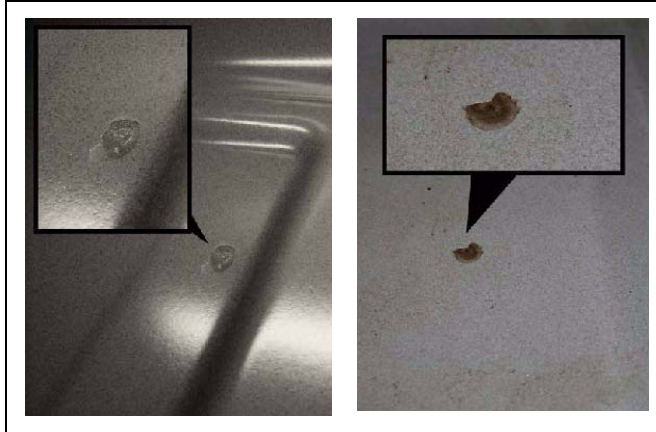
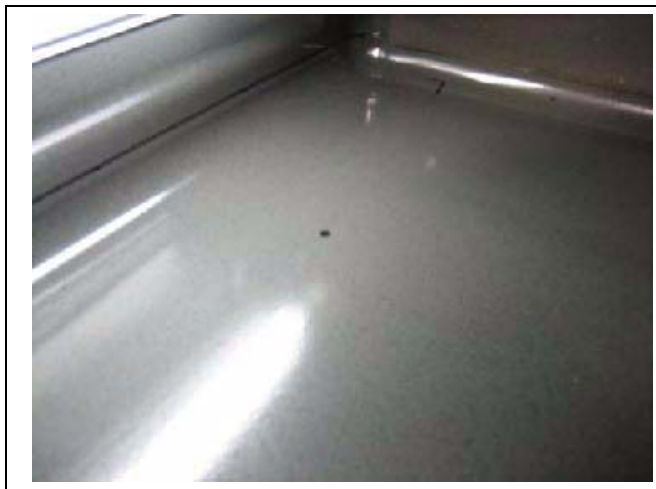
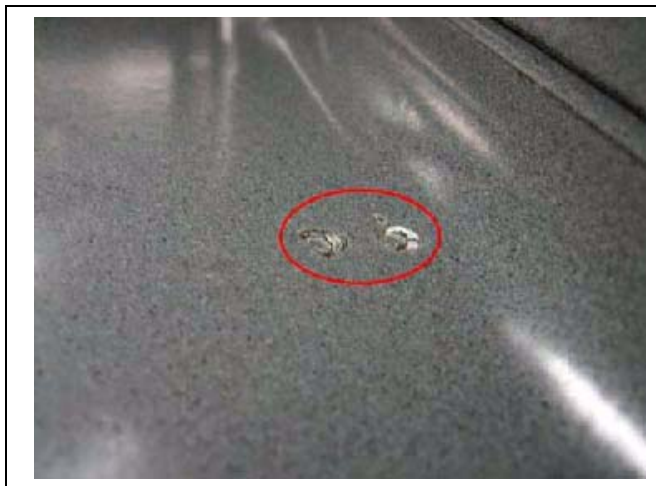
General flaking in the oven/oven floor

Flaking enamel at any points in the oven, the impact point (dent) is tangible in the centre, also partly visible.

Cause of damage:
Improper handling (falling down) of hook-in grille/bars, telescopic runners, or baking/roasting accessories.

✘ No warranty claim!

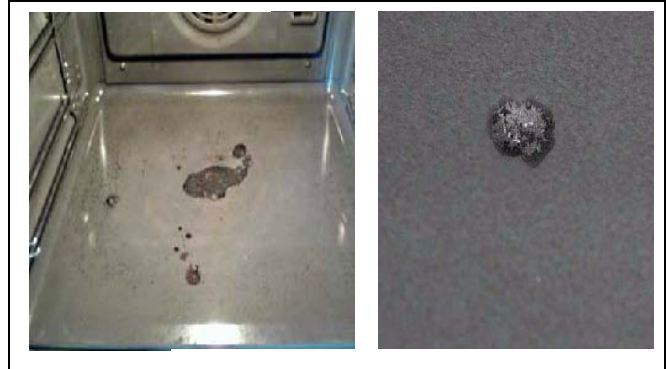
Colour difference or stains on the oven floor

Varnish, stains and colour differences on the oven floor.

Cause of damage: Acid residue.
Fruit juices leave stains which can often no longer be removed!
Enamel then becomes lighter in that location.

If the residue cannot be removed, this is lacking/discolouration, e. g. caused by fruit acid.

✘ No warranty claim!

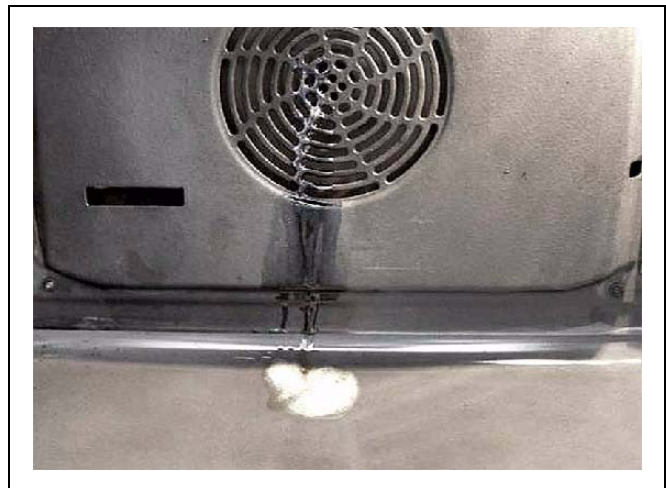
Traces of molten material on the hot air conduction plate

Cause of damage:

- Improper handling, packaging (polystyrene strips) was not removed before the appliance was used for the first time.
- Melted plastic residue on the hot air plate.

✘ No warranty claim!

Follow information in the instructions for use, see "Before using the appliance for the first time".

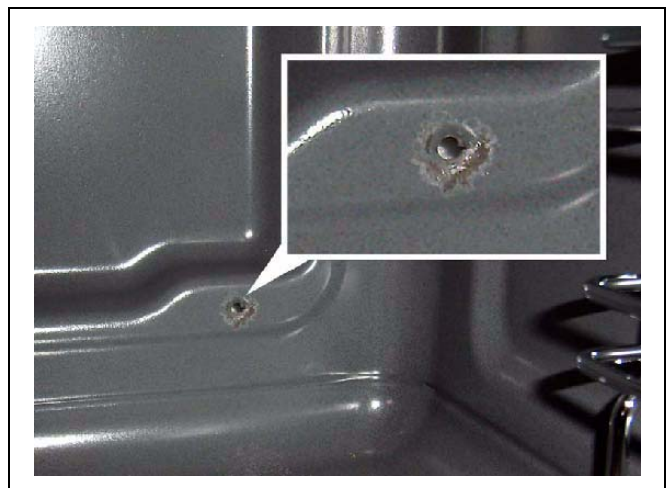
Flaking on attachments of hot air conduction plate

Cause of damage:

When the screws are being unscrewed, small pieces of enamel may drop off the bores. This is production-related, does not indicate a functional defect and is not visible following installation of the hot air plate.

✘ No warranty claim!

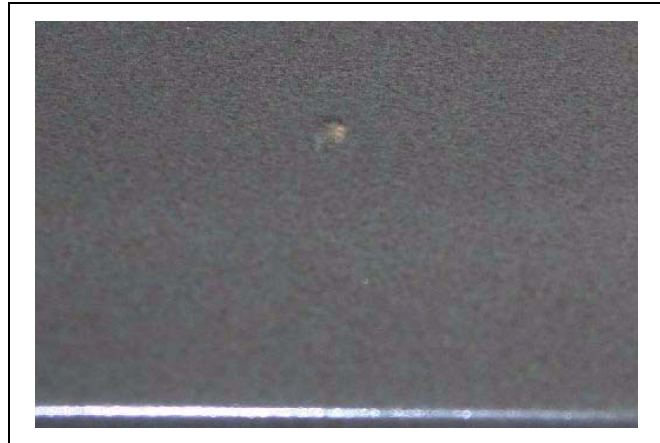
Enamel ridge tangible (no flaking)

Enamel ridge is production-related und does not indicate an impairment of the function.

**No warranty claim!**

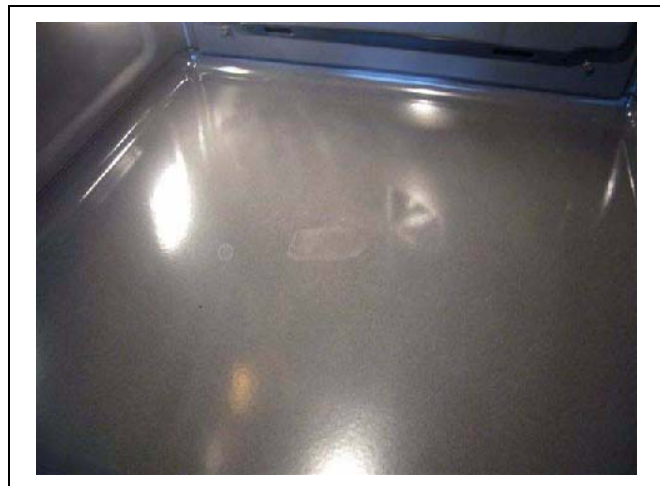
Enamel cracks (metallisation) in the oven floor / White edges in the oven floor

We know of enamel cracks in pyrolysis appliances only. The first, visible occurrence may be established after 10–12 pyrolysis cycles. Usually they are on the oven floor, occasionally also on the base of the ribs.

Hairline cracks which do not reach the carrier material:

These represent only a slight optical impairment. A warranty claim cannot be deduced from this. These enamel cracks are recognised by their fine branched lines, usually dark in colour.

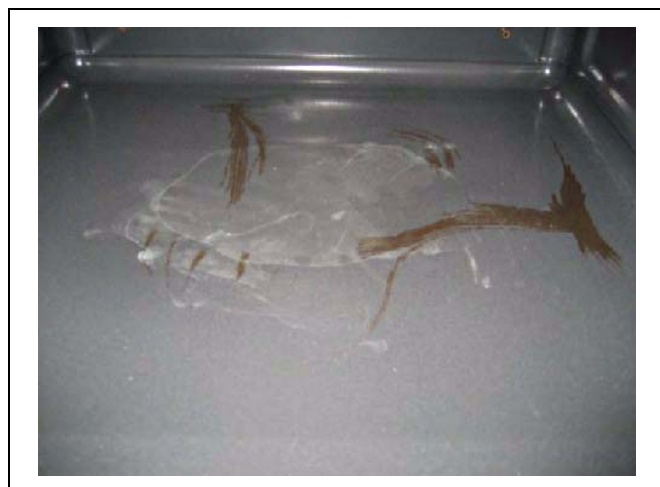
Hairline cracks which reach the carrier material:

These promote corrosion on the carrier material. The oxide, red in colour, comes out of the enamel crack.

Causes of damage for these enamel cracks:

- Water was spilled on the hot oven floor. This can be recognised by visible limescale edges on the oven floor.
-

Clean limescale edges with vinegar water.
- Enamel layer applied too thickly (manufacturing fault). Can be recognised by enamel cracks without limescale edges.
-

**No warranty claim for limescale edges!**

**Warranty claim for enamel cracks without limescale edges!**

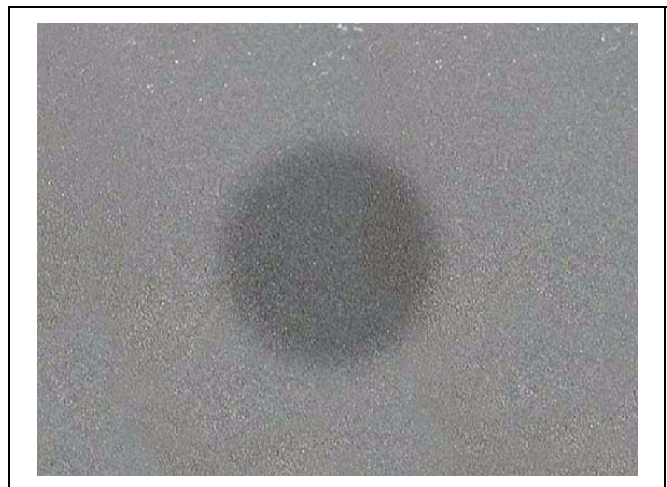
Colour deviation visible in the enamel

The enamel is smooth in this area and has no ridge or depression.

Fused in pigments!

This is production-related und does not indicate an impairment of the function.

**No warranty claim!**
