Austausch des Abluftstutzens aus Metall gegen eine geänderte Version aus Kunststoff

Betrifft Modell: MWGD 750.0

Replacing the metal air vent with a modified plastic version Concerns model: MWGD 750.0

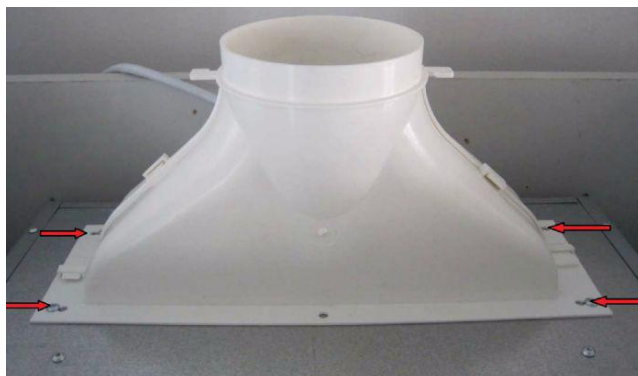
Abluftstutzen neu ET-Nr. 545885.

Bei Änderung der Leistungsstufen erfolgt keine Änderung der Motordrehzahl. Das Laufgeräusch bleibt auch bei Änderung der Leistungsstufe immer gleich. Die Saugleistung ist ungenügend.

Der neue Abluftstutzen ist um 96mm höher als der alte. Abhängig von der Abluftführung ist deshalb die Montage des geänderten Stutzens nicht immer möglich.

Der Abluftstutzen aus Kunststoff wird mit vier Schrauben befestigt.

The new air vent is around 96mm taller than the old one. It is thus not always possible to install the modified air vent; this depends on the outgoing air duct.

The plastic air vent is secured with four screws
