IKD1157.1 E and KD957.1 E - Factory 77 **Grease drips from the motor into the rear halogen lamp**

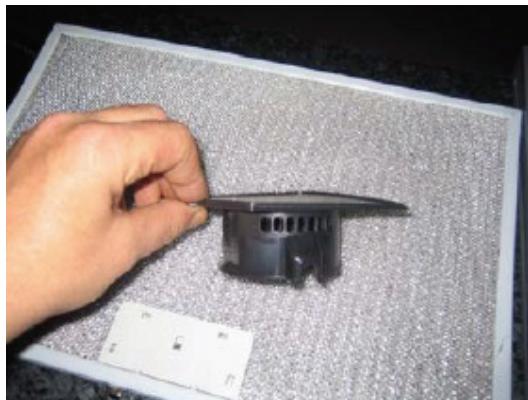
Fig. 1 Plastic cover

For cases in which the exhaust air duct has no fault or if it is no longer possible to modify the exhaust air duct we have developed a plastic cover (spare-part no. 531428).

This cover is mounted onto the rear halogen lamp.
