Motor house and turbine interference EDIP 9500.0 / EDIP 6500.0

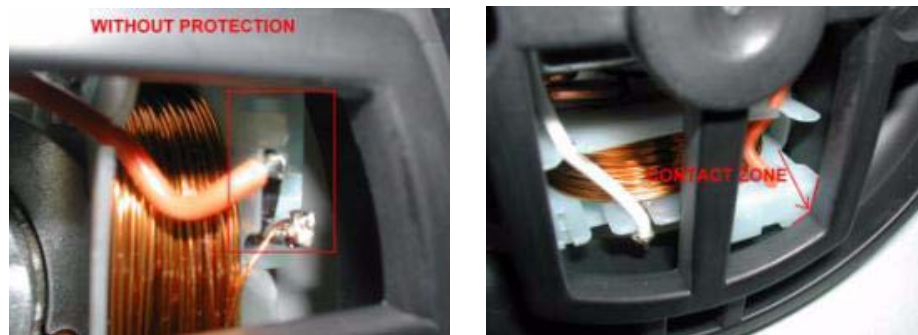
It was detected that one of the motor suppliers has been supplying motors with a plastic cover for protection of the thermal cut out. This protection does not allow a proper placement of the electric motor in the plastic motor base, so that the motor axis is not perpendicular to the plastic motor base. It makes the turbine to get out of its normal position interfering with motor house.

Figure 1: Thermal cut out with and without plastic protection

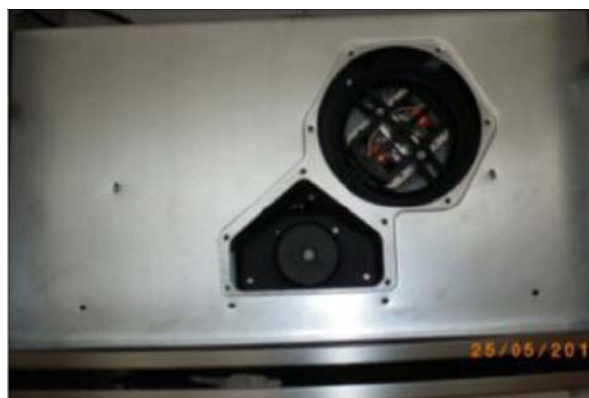
Figure 2: Hood motor

Remove the hood from the kitchen furniture. Remove the motor plate cover.

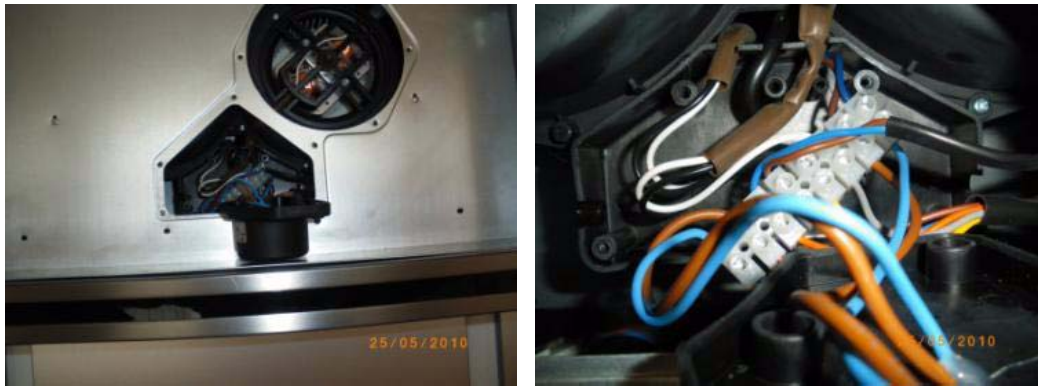
Figure 3: Release motor wires

1. Unscrew locking position screw.
2. Remove terminal block cover and motor wires.

Please see wiring diagram to make sure you are connecting the motor wires back in its right position!

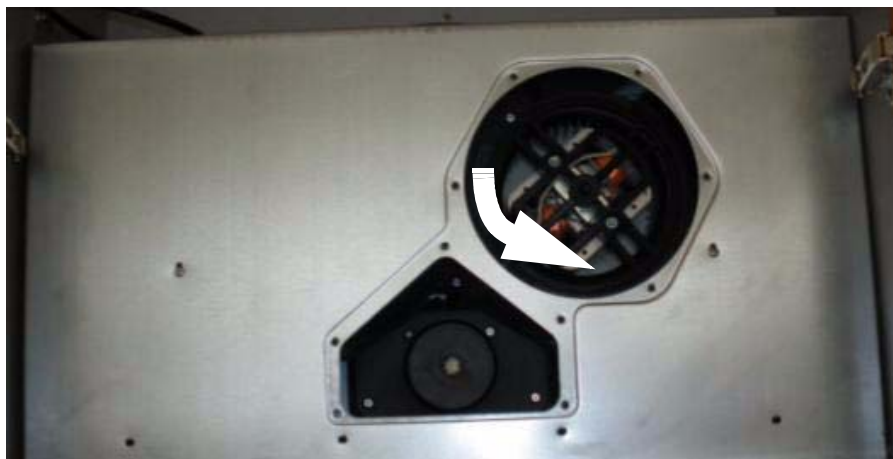
Figure 4: Remove motor base

3. Turn the motor base to release it from the motor house.

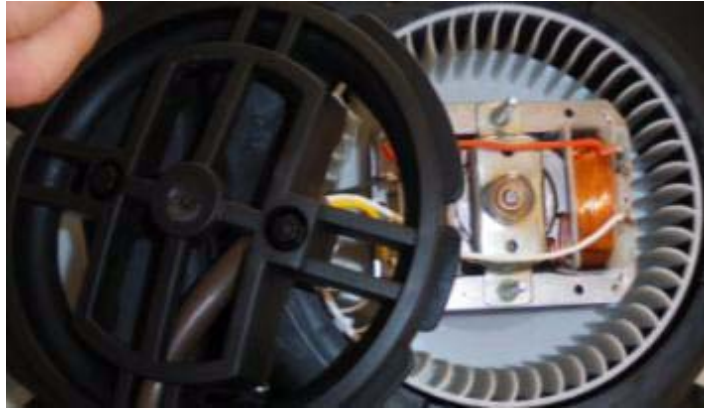
Figure 6: Remove the motor base

5. Remove the motor base so that you can access the plastic cover of the thermal cut out.

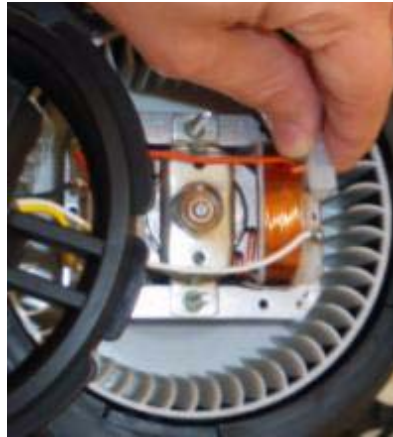
Figure 7: Remove plastic cover

6. Finally, remove the thermal cut out plastic cover manually.

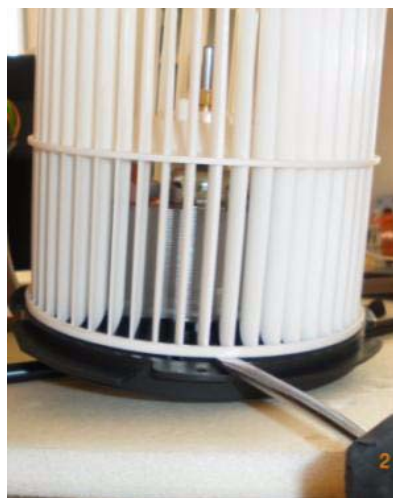
Figure 8: Make sure there is not turbine vs motor base interference before placing it back.

7. Place the motor base back and make sure the turbine is not interfering with the motor base or the motor house.
