Leakage, noise and steam/moisture IGV 645.1/2

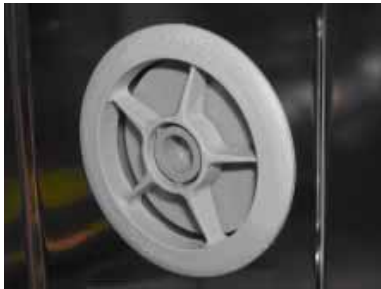
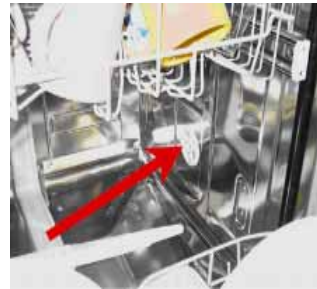
6. The third possibility to prevent damages on the kitchen furniture after a longer time is to install a "throttle disc" into the connection from tub to the drying system. This disk can be installed very easy by opening the dishwasher door, remove the grey plastic union nut, insert the throttle disk into the union nut and build in the nut again to the connection hole like shown on below picture.

Spare part number for silicon	435 454
Spare part number for "throttle disc"	435 455
Spare part number for this cover:	435 456
Spare part number for the steam protection foil:	434 799
Seal spare-part no. (2 mm)	434 765

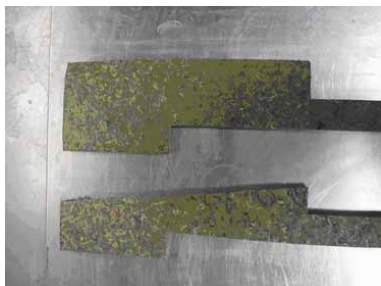
Cutting the insulation strip on the capacitor of the dryer in order to improve the flow of air (see arrow).

In order to improve the flow of air in the top part of the appliance too, the upper insulation mat must be modified (see arrow).

1. Check the 3 mm gap between the appliance and the kitchen worktop.
2. Reduce the thickness of the front insulation strip by half by pulling the insulation strip apart in order to ensure a minimum gap of 3 mm between the top cover and the appliance (illustr. bottom right ①).
3. Change the insulation. See the following illustrations.
