IKE458-4-4T -Overflowing defrost water tray

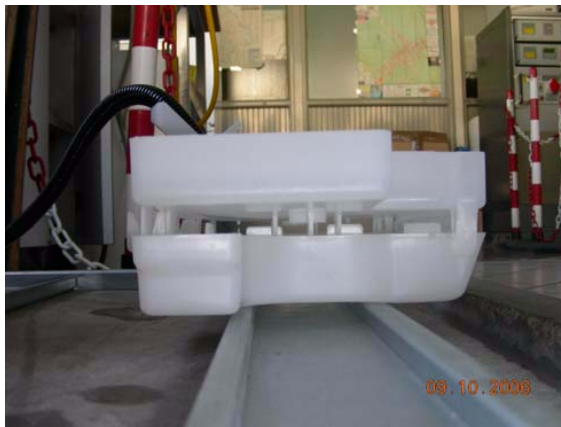
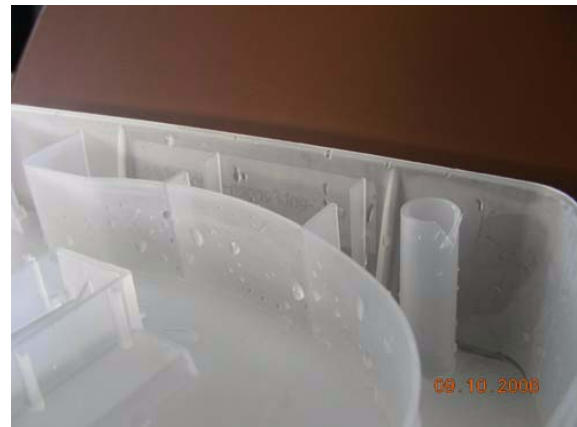
1. Position the drip collecting tray from the kit at the level of the cross bar located in front of the compressor.
2. Cut a notch into the discharge pipe of the vapour tray located on the compressor as shown on the illustration.

Please note: the fastening teeth on the bottom of the tray ensure that the tray is correctly positioned.

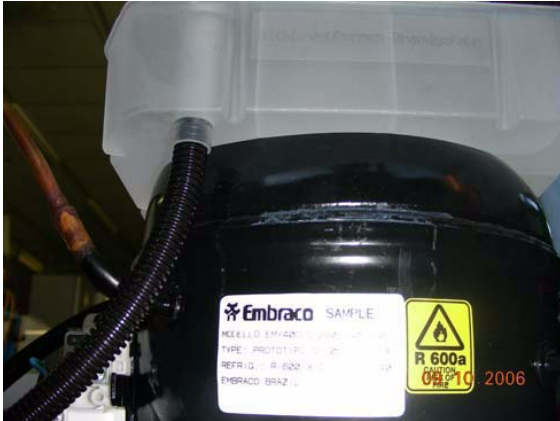
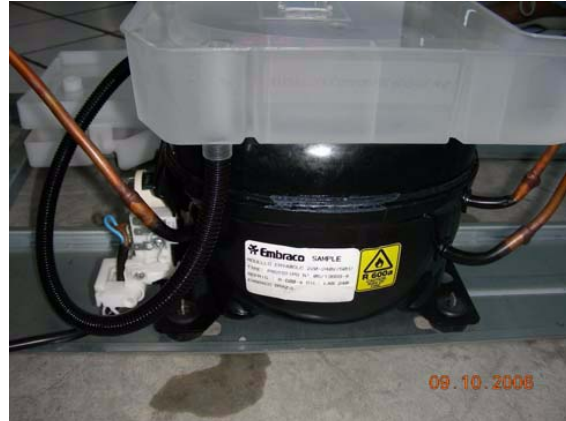
3. Guide the water discharge hose into the vapour tray located on the compressor.

Please note: apply silicon around the water discharge hose in order to prevent any water from leaking out.

4. The water discharge hose is guided behind the compressor, as shown on the illustration.

Ensure that the water discharge hose does not touch the compressor in order to prevent the water hose from becoming deformed or perforated.

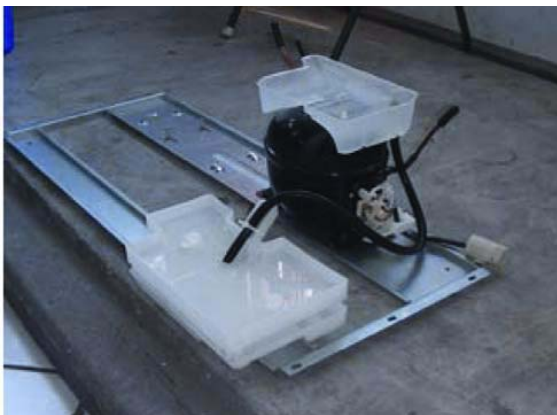
5. Cut off the protruding part of the hose and fasten it to the drip collecting tray with a hose strap.
