**IKEF 329-0****Excessively high temperature in the refrigeration unit of model IKEF 329-0 - 178 niche 0° cooler****Description**

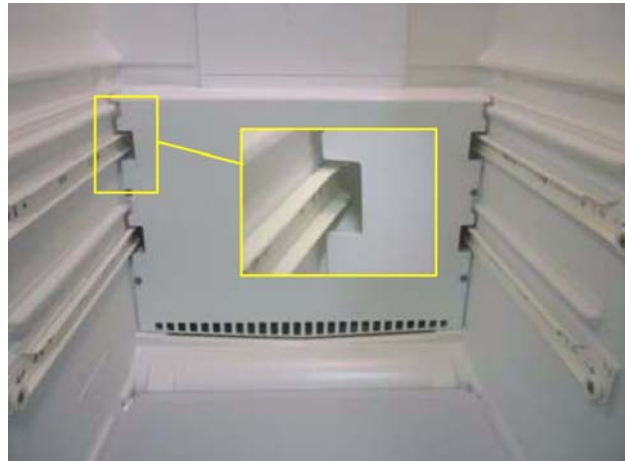
This fault may be caused by the improper circulation of air inside the refrigerator: the air that is forced towards the evaporator from the fan does not reach the evaporator; instead it escapes from the air channel through the cover where the top drawer rail is located.

Users may hence complain about an excessively high temperature in the 0° compartment and/or about an excessively high temperature (9°-10°) in the refrigeration unit. This may occur when the evaporator or the holder made of polystyrene foam located behind the cover is not properly fastened.

The problem can be solved by simply removing the cover and positioning the evaporator and the polystyrene sheet plate properly so that they block the two openings where the drawer rail is located.
