Vibration noises on the condenser

Models affected:

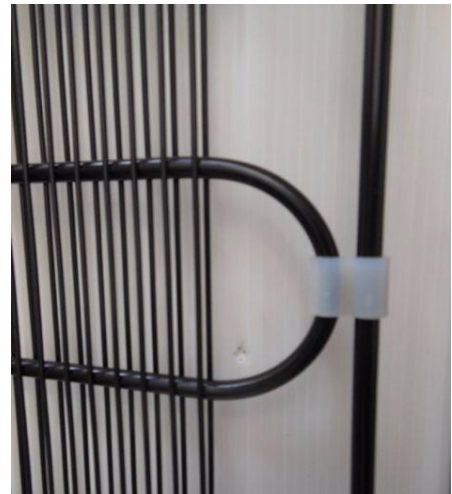
In the built-in, combined fridge-freezers with an electric valve (see below for PNCs), noises on the condenser may result when compressor vibrations are passed on the the condenser. The noise is cause caused when vibrations are transferred to the long, freely suspended pipe.

Use plastic clamps (**spare-part no. 441797**) to fasten the long, freely suspended pipe to the condenser. Each **spare part no.441797** comprises 1 clamp, 1 pipe clip, condenser
