## Motor house and turbine interference CNX 6000 / CNL 3000

### 1 Introduction

It is the aim of the present technical information to explain how to solve the interference problems between motor house and turbine in the above mentioned models.

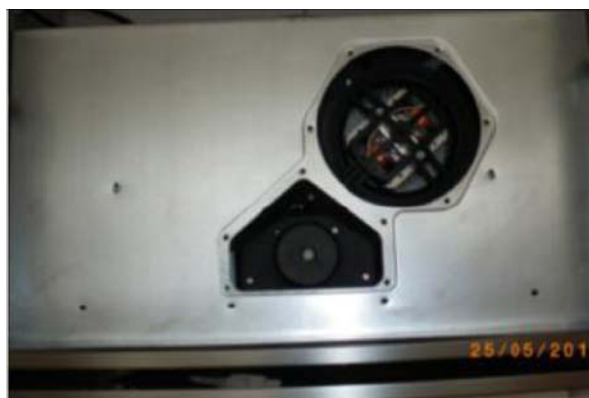
Figure 2: Hood motor

Remove the hood from the kitchen furniture. Remove the motor plate cover.

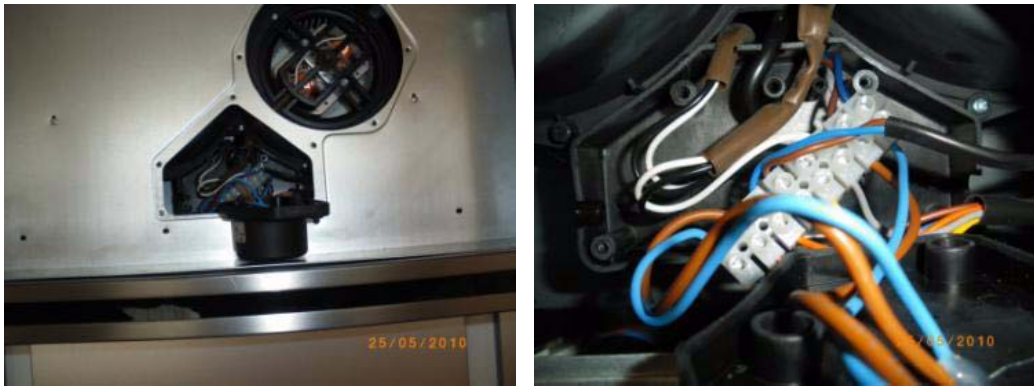
Figure 3: Release motor wires

1. Unscrew locking position screw.
2. Remove terminal block cover and motor wires.

Please see wiring diagram to make sure you are connecting the motor wires back in its right position!

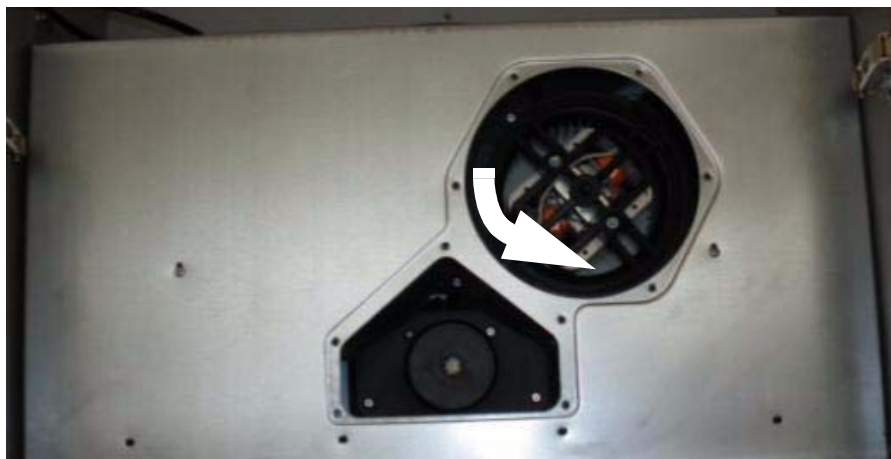
Figure 4: Remove motor base

3. Turn the motor base to release it from the motor house.

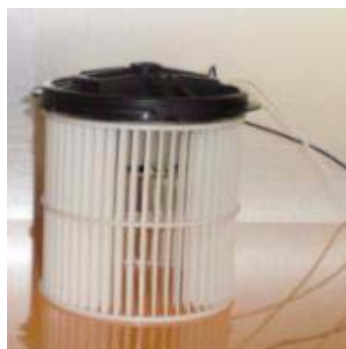
Figure 5: Hood motor

4. Remove the motor out of the motor casing and place it in a table.

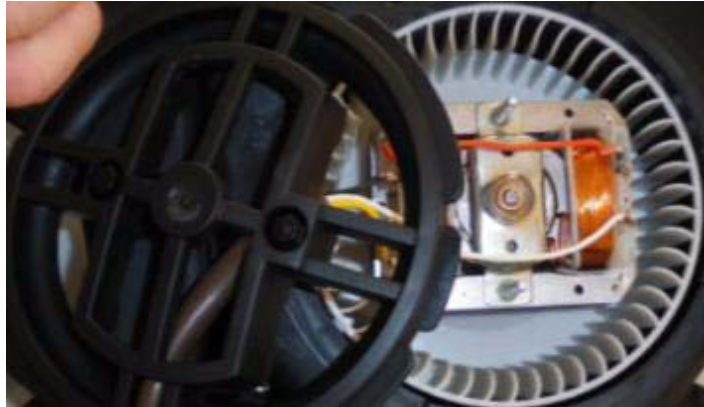
*Figure 6: Remove the motor base*

5. Remove the motor base so that you can access the plastic cover of the thermal cut out.

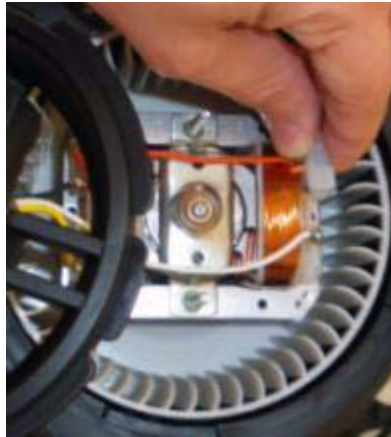
*Figure 7: Remove plastic cover*

6. Finally, remove the thermal cut out plastic cover manually.

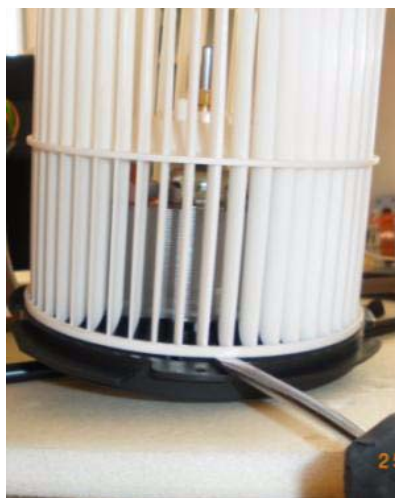
*Figure 8: Make sure there is not turbine vs motor base interference before placing it back.*

7. Place the motor base back and make sure the turbine is not interfering with the motor base or the motor house.
