Responsible: U. Laarmann  
Date: 23.05.2006

### KD12450.O E and KD9450.O E: burned ribbon cable

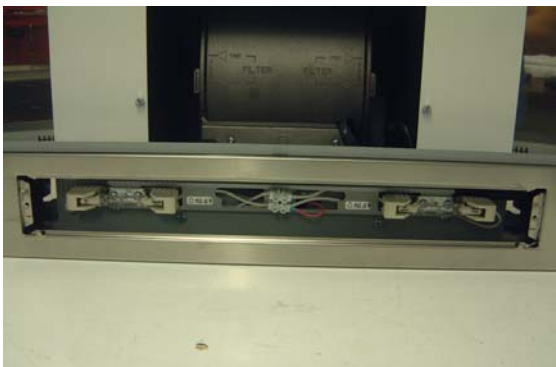
Old model before removal

The glass of the lamp will need to be removed before the new lamp bracket can be installed. Then loosen the screws of the lamp bracket and disconnect the electrical connection.

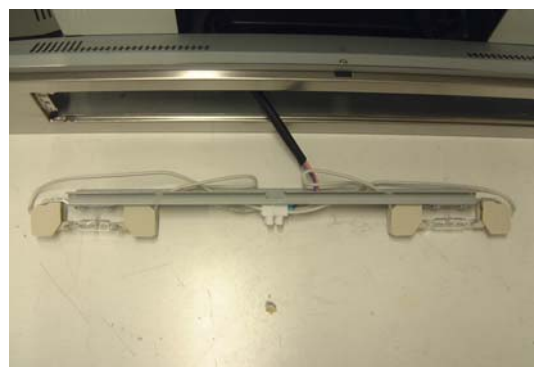
Old model after removal

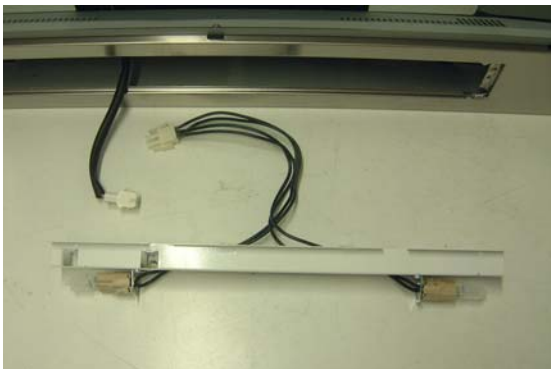
New model before installation

Installation of the new lamp bracket is carried out in reverse order.

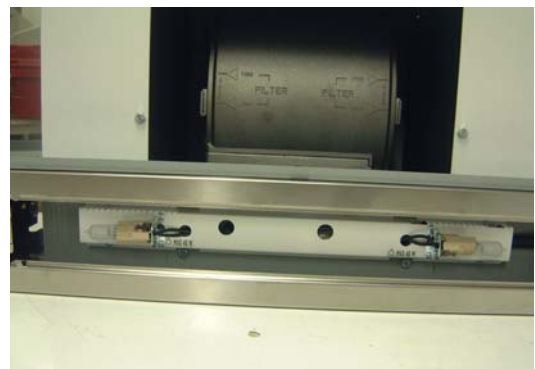
New model before installation

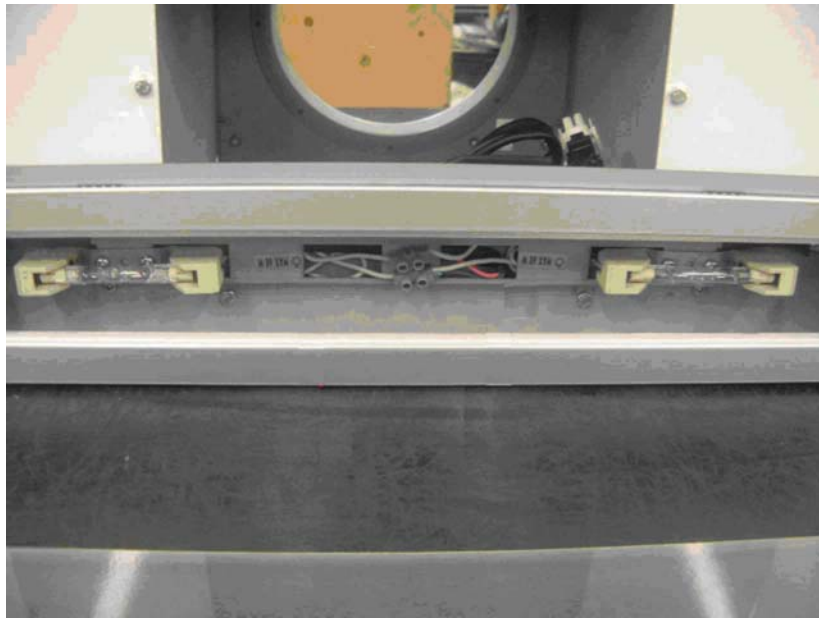
When the lamp of the hood operates constantly, the heat given off by the 60W/240V halogen lamps may cause the ribbon cable (spare-part no. 56 54 77) between the electronics unit and the control unit to burn, resulting in various problems with the controls.

Old 240 V/50Hz /60W model

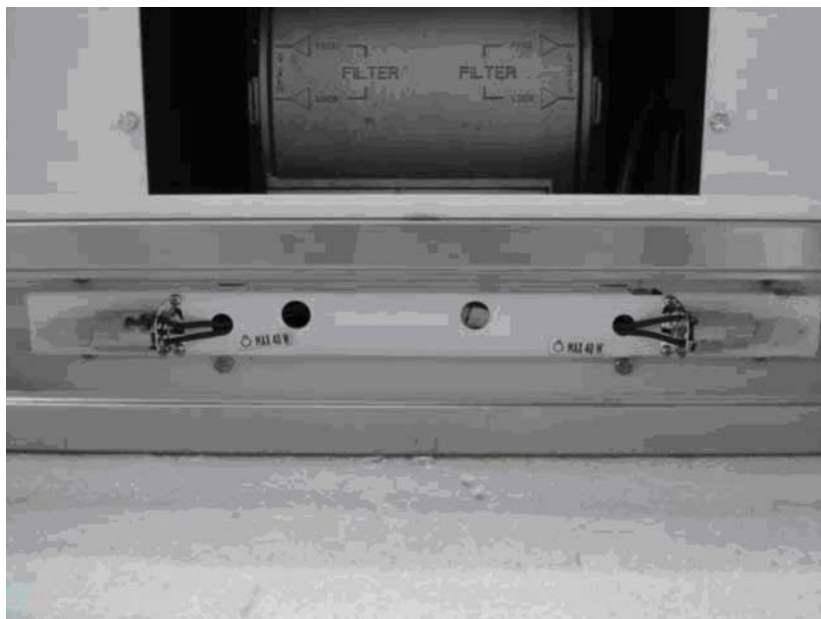
New 240V/50Hz/40W model

A repair kit can be ordered under spare-part no. 53 19 06 when problems like this occur. In this kit the 60W/240V halogen lamps have been replaced with 40W/240V halogen lamps and a lamp bracket.
