Problems during top basket washing

New Structure 60 cm - Electromechanical Dishwashers

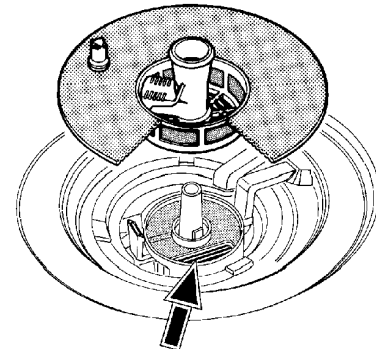
FUNCTIONAL TEST

- Set the timer to pre-wash «D», perform several start-up and drain operations and check the discharge pump for perfect operation.
- Optimum pumping-out has been achieved if, after the 60" pumping-out phase, the residual water level in the sump is lower than the filter tower edge and the filter tower interior (see illustration).
