Responsible: D. Rutz
Date: 22.07.2004

Rubber outlet of the circulation pump Models:IGV 645.0 / .1 / .2

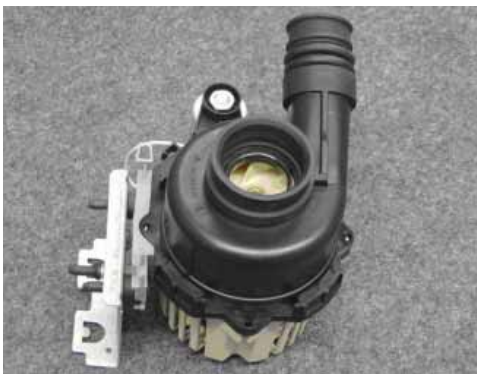
LOW NOISE MOTOR (alternating)
Spare parts n. 435 450

Possible leakages or noises on the circulation pump. Check the rubber outlet of the circulation pump to the sump. Now it is possible to order the circulation pump itself. It is not longer necessary to change the whole motor/pump unit. To avoid wrong orders, please have a look on the below mentioned pictures to the different motors. Take care on appliances with CESET synchronous-motors for permanent and alternating washing system. On the housing of the pump, you can find a "L" or a "H" on the end of the labelling. "L" for low pressure pump and "H" for high pressure pump.

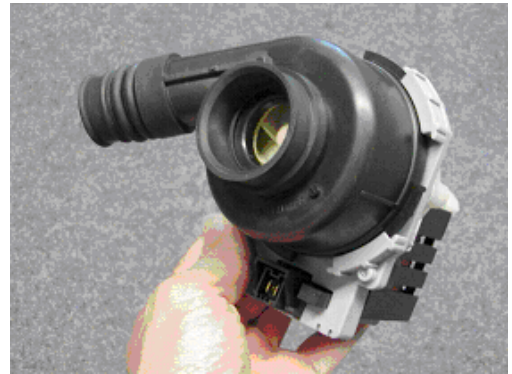
ASYNCHRONOUS MOTOR (permanent)
Spare parts n. 435 451

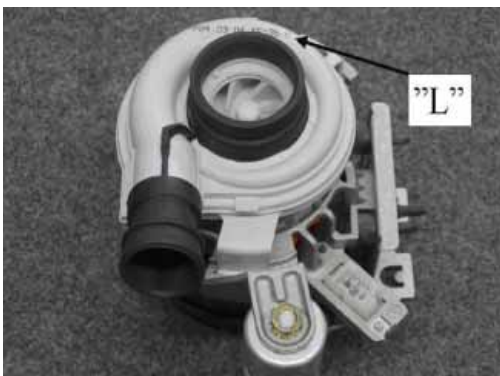
CESET SYNCHRONOUS MOTOR
(alternating)
Spare parts n. 435 452

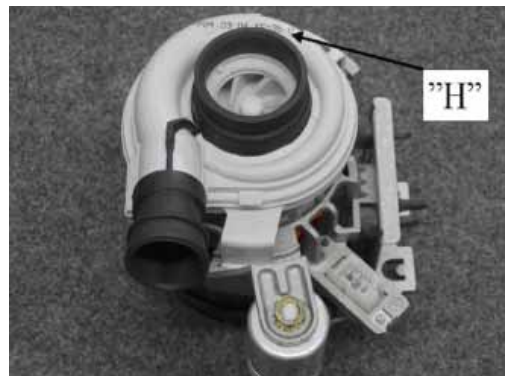
CESET SYNCHRONOUS MOTOR
(permanent)
Spare parts n. 435 453
