KE 650-2-2T

Set for adapting the resistance conduit for the illumination of the issuing box (Spare-parts No. 431368)

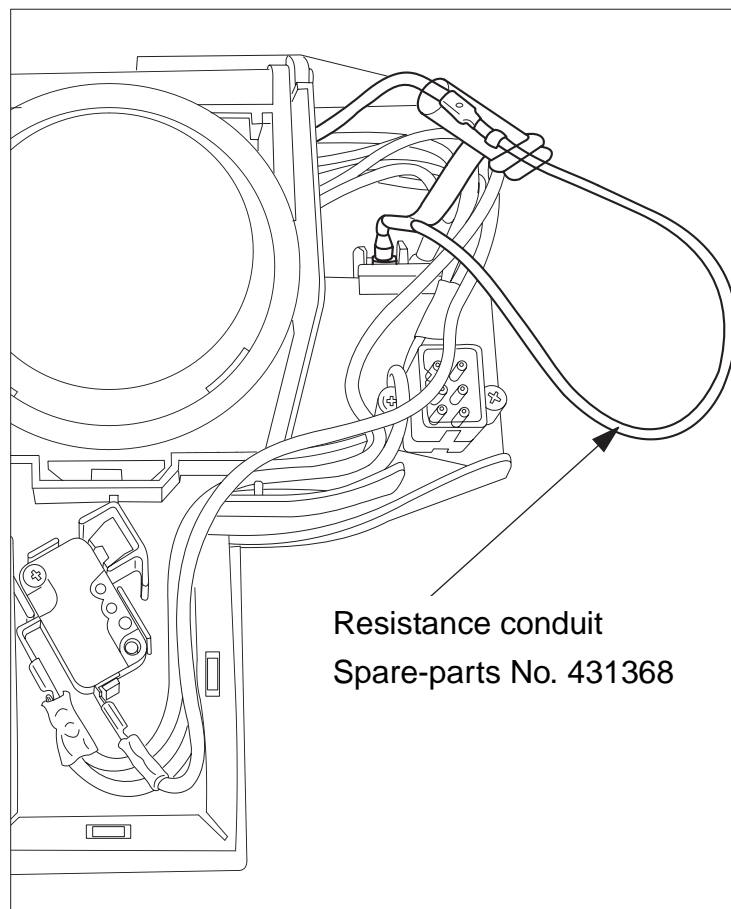
If a light bulb in the issuing unit burns out there might be a possibility of high voltage flowing for a short time, destroying the TRIAC and also other components on the control chip. In this case several components can be provided with permanent voltage, so that subsequent damage is likely to occur.

As of about February 2001 a resistance conduit with a resistance of $60 \Omega \pm 7\%$ will be added to the power supply for the light bulb.

In order to adapt the resistance conduit, the black cable has to be removed from the holder and to be connected with the coupling of the resistance conduit. The other end of the conduit must then be put into the free plug-in of the holder.

This minor adaptation should be carried out generally when doing maintenance work and repairs on other appliances of customers who own a KE 650-2-T.
