Responsible: U. Laarmann  
Date: 03.07.2008

## No refrigerating capacity for KE 360-1-2T appliances

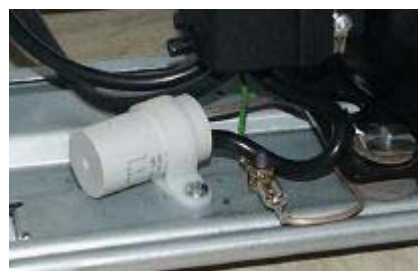
Fasten the mains filter to the compressor holder.

### Installing the mains filter (spare-part no. 438176)
