## Turntable motor with 2.5/3 r.p.m.(Metallic shaft)

**References involved:** MC 32 BIS; MW 32 BIS; MW 32 BIT

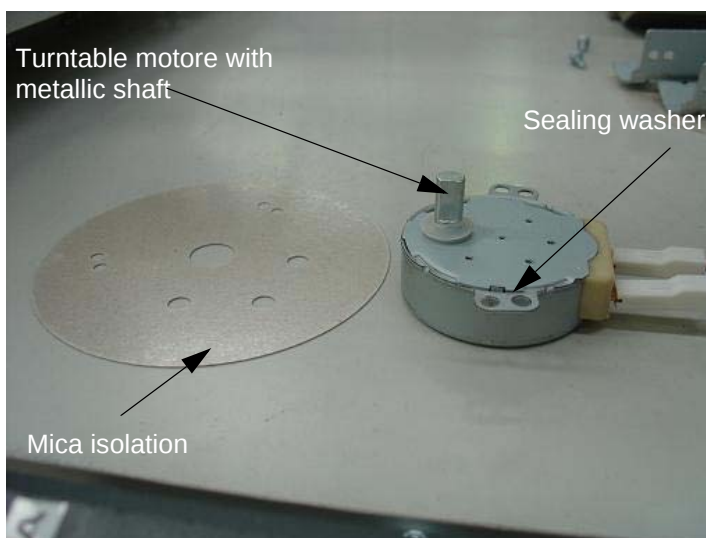
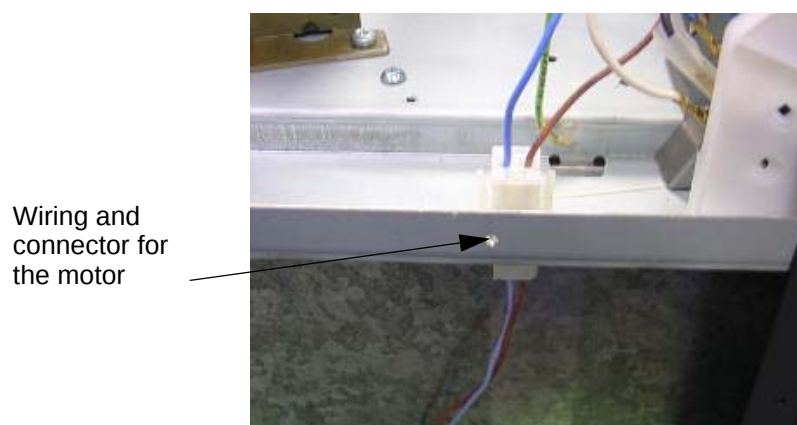
If a fail occurs in the turntable motor verify:

- the value of the coil between the terminals should be 14.7 K $\Omega$  ;
- if the connector of the wiring has good contact.

Spare-parts n. 162030 - Turntable motor with metallic shaft

Spare-parts n. 163223 - Sealing washer for turntable motor

Spare-parts n. 163220 - Isolation Mica
